#### Sky Ranch Estates - Owners Association

Sky Ranch Estate Reservoir

09/03/2019

On September 3<sup>rd</sup>, 2019 Blue Locker Commercial Diving Services, L.L.C. performed a cleaning and inspection of the Sky Ranch Estates Reservoir for the Sky Ranch Owners Association. This report, along with the provided video, documents the findings of the inspection.

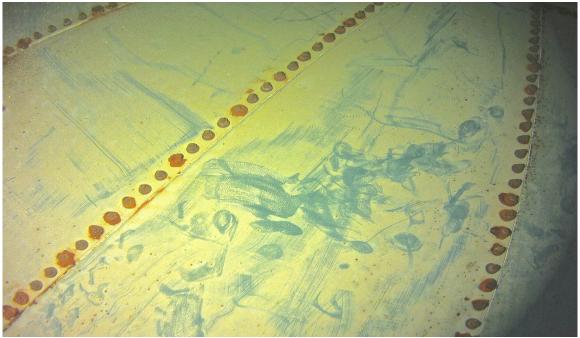
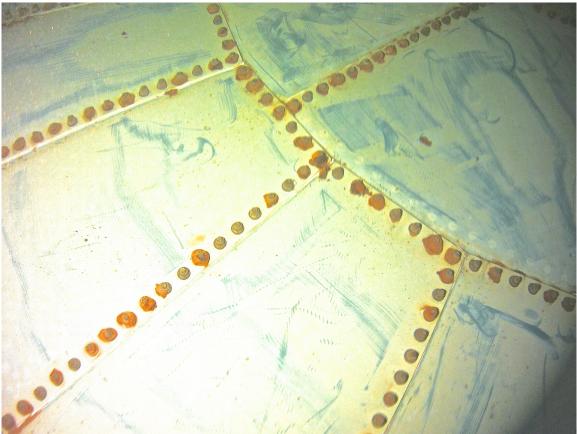
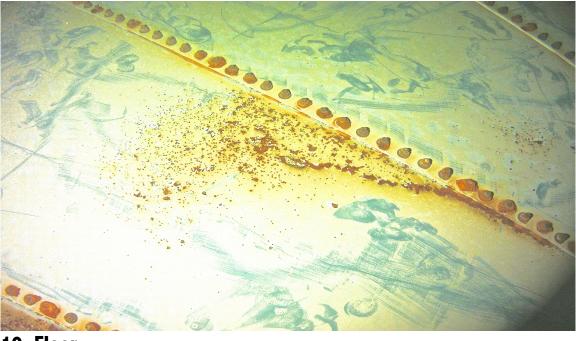
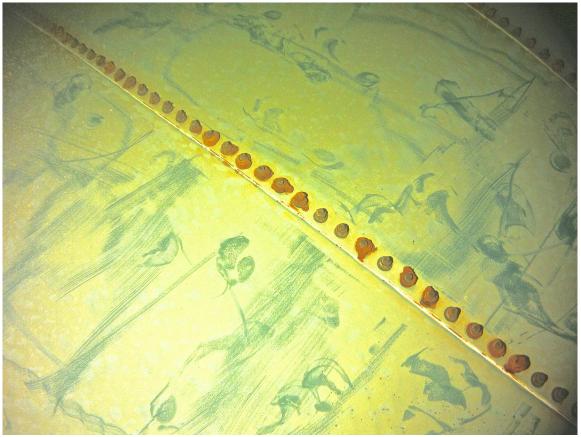
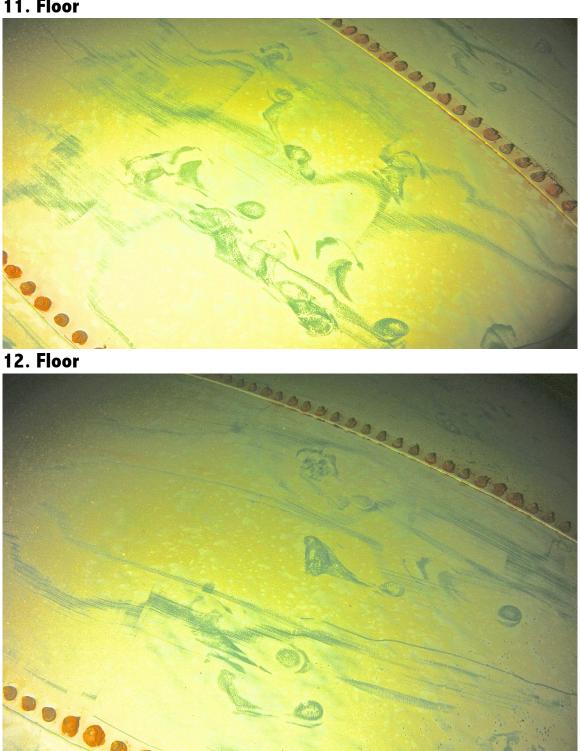
- Floor coating good condition.
- No cracking, peeling or blisters observed.
- Rust on nuts and bolts at seams thru-out tank.
- Rusty debris from inlet stuck to floor under inlet.
- Surface of coating is chalky.
- 1/8' 1/4" of sediment and debris was removed by divers prior to inspection.
- Recommendations:
  - See shell.

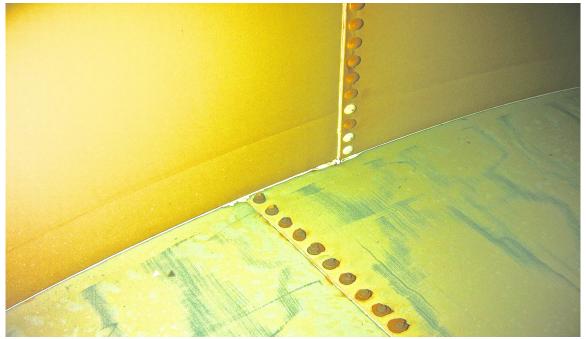
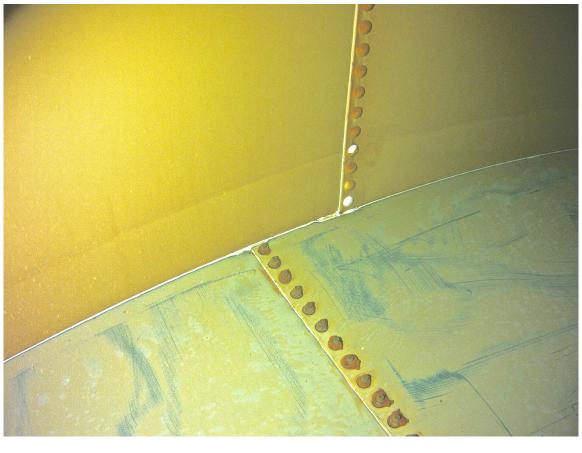
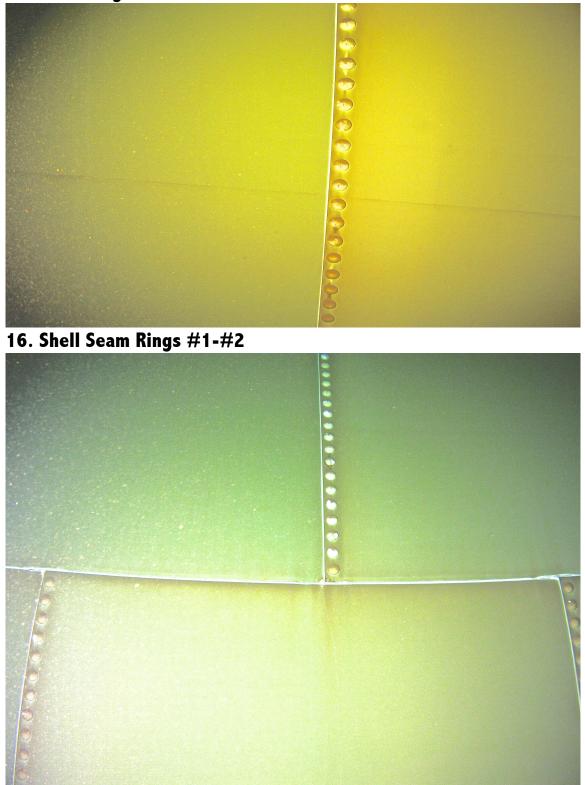
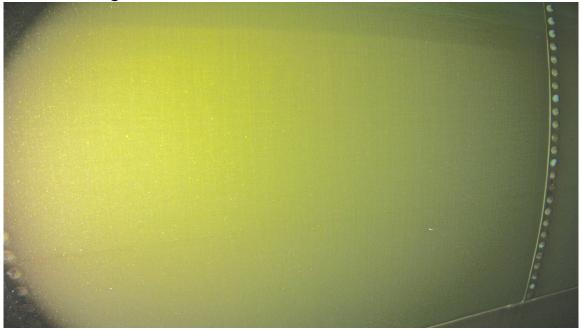
- Interior coating good condition.
- No cracking, peeling or blisters observed.
- Rust observed in crevice where shell meets ceiling.
- Rust seeping out from under plastic on bolts at seams.
- Surface of coating is chalky.
- Recommendations:
  - Coating is chalky which indicates the coating is beginning to reveal its age.
  - Inspect again within 3 years to check for how much oxidization has occurred.

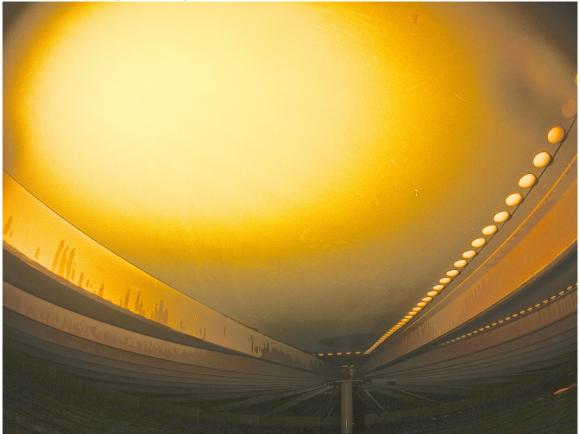
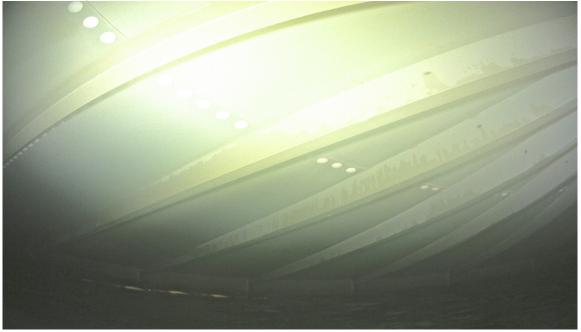
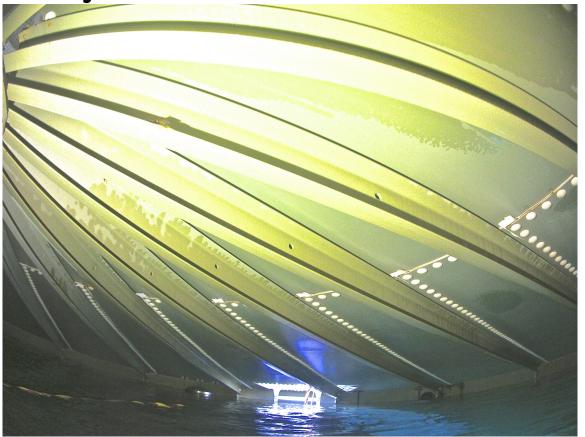
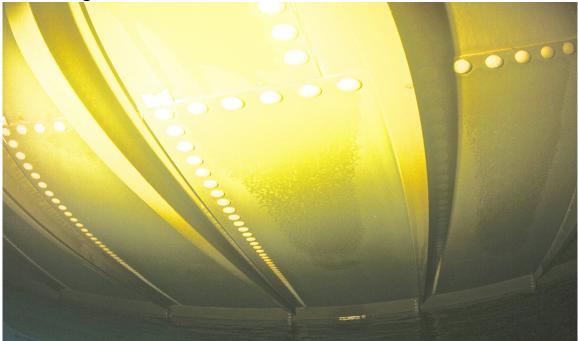
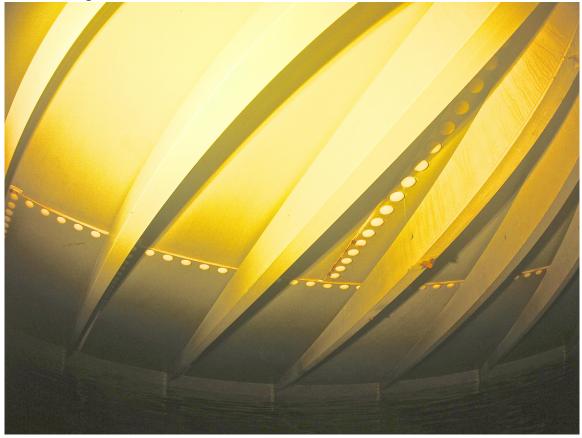
- Ceiling coating good condition.
- No blisters observed.
- Coating on beams at top-hat is peeling exposing rusted steel.
- No other flaws observed.
- Recommendations:
  - See shell.

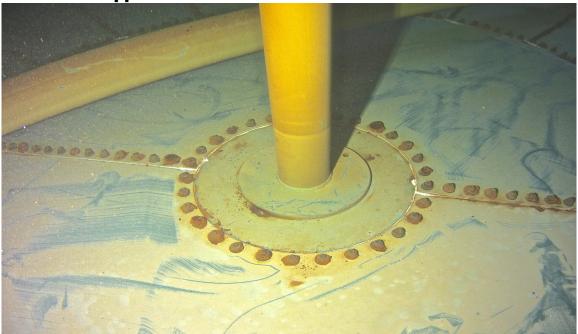
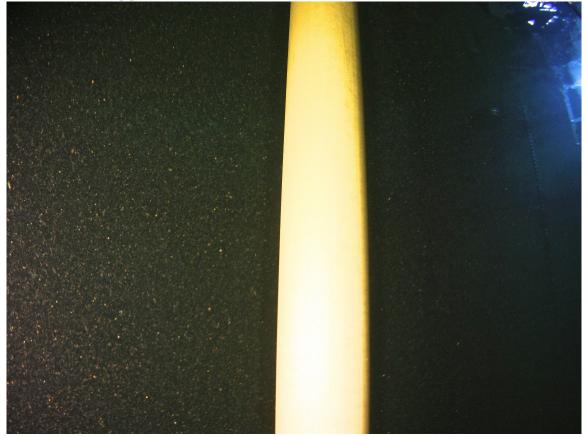
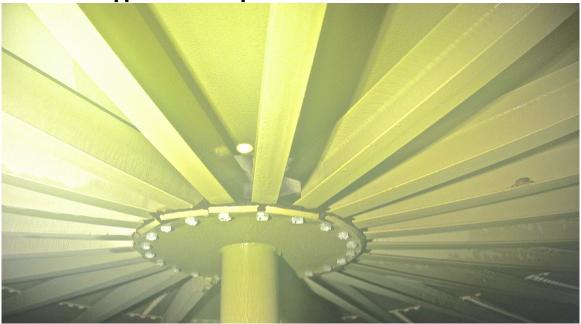
- 1 Center support pole good condition.
- No flaws observed in coating other then peeling on the beams above top-hat.
- Recommendations:
  - o NA.

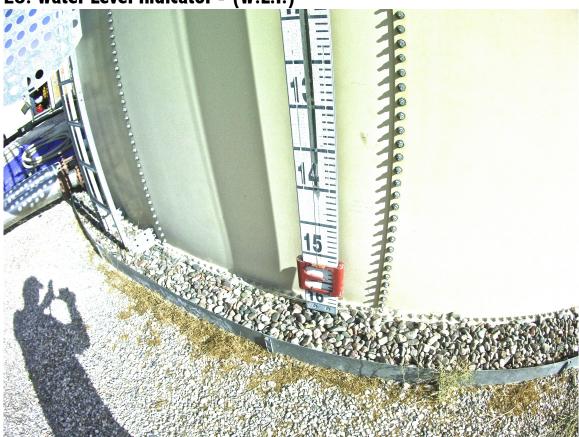
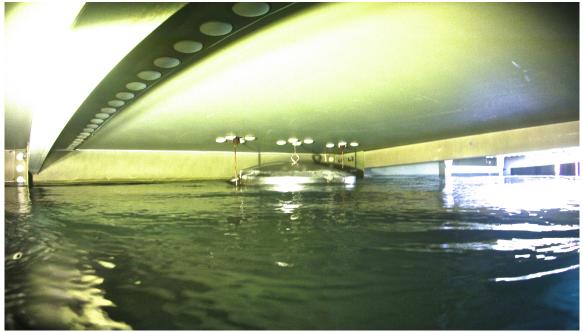
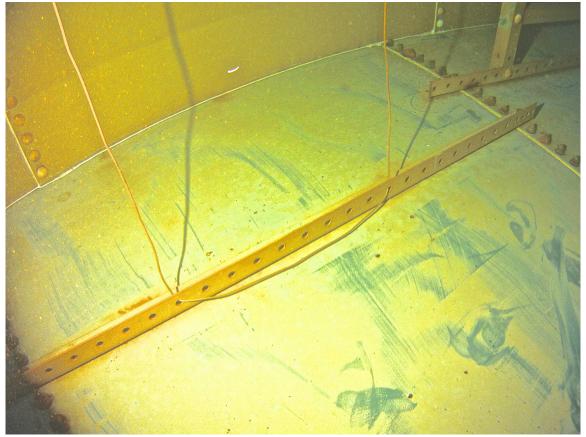
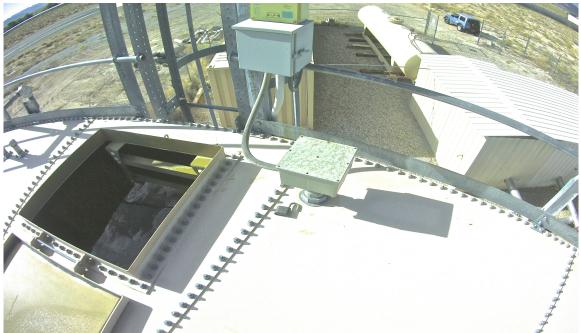
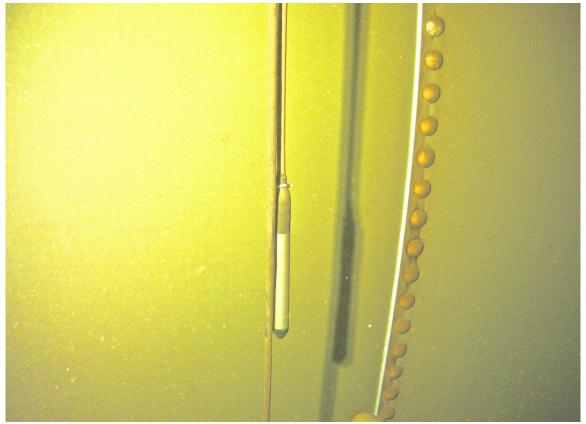
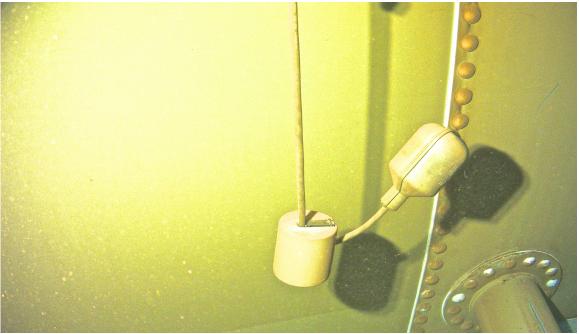
- Mechanical Water Level Indicator (W.L.I.) is in good condition and appears functional with the float at surface and guide wires intact.
- Hi-Water float is in good condition and functional.
- W.L.I. Transducer is in good condition and functional, hangs approximately 4' off the floor.
- Recommendations:
  - It appears all requirements per NAC 445A.6708.7 have been met.

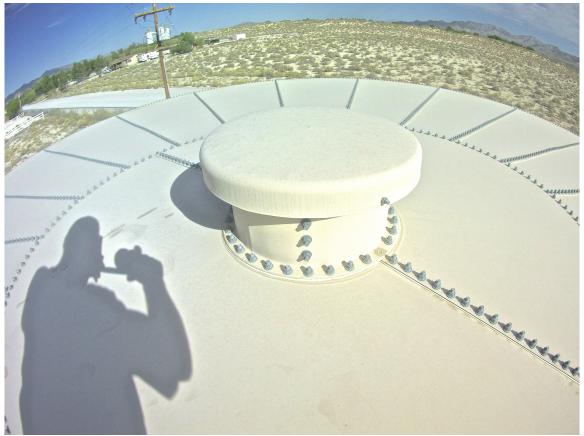
#### 34. Center Roof Vent

- 18" Diameter center roof vent good condition.
- Screen is intact
- Recommendations:
  - Ensure screen mesh is 22-24 mesh per NAC 445A.6708.5

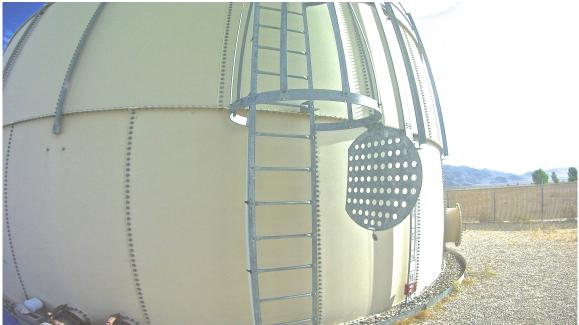
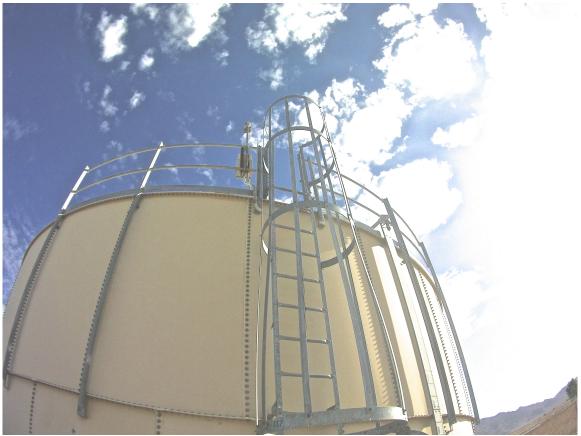
- Exterior ladder good condition.
- Ladder is galvanized and secure to shell.
- No flaws observed on rungs, runners or cage.
- Safety climbing device (cage) good condition.
- Recommendations:
  - o None

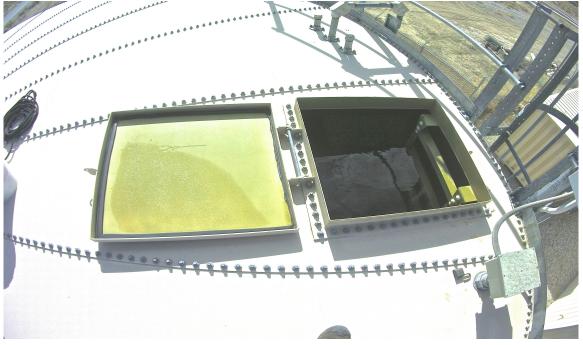
#### 37. Access Hatch

- 30" x 30" Access hatch good condition
- No cracking, peeling, or blisters observed.
- No flaws observed around opening or on hatch cover.
- Recommendations:
  - Replace/repair gasket to remain in compliance with NAC445A.6708

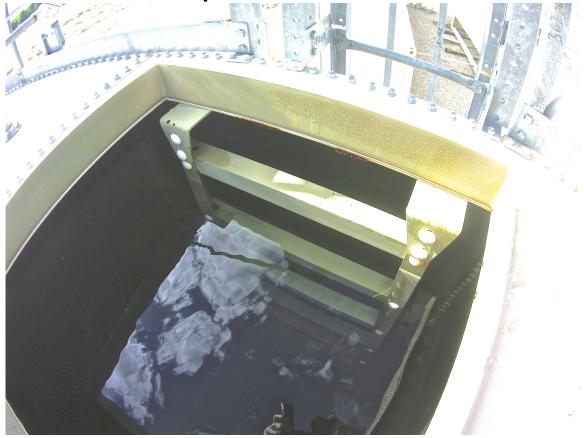
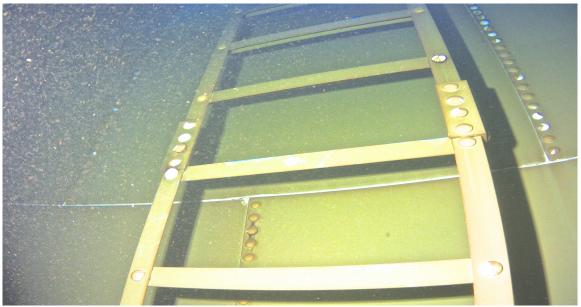
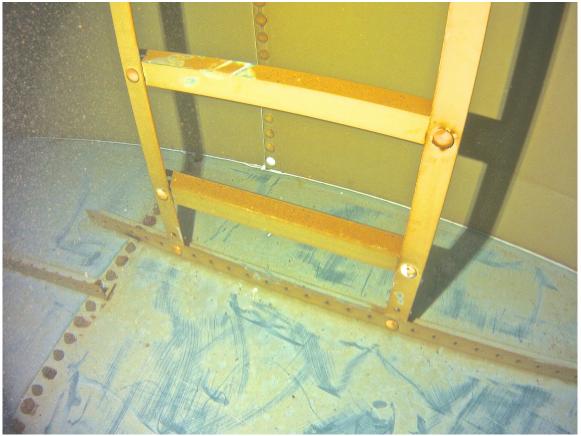
- Interior ladder good condition.
- Structurally sound and secure to shell.
- No flaws observed on rungs or runners.
- Recommendations:
  - o NA.

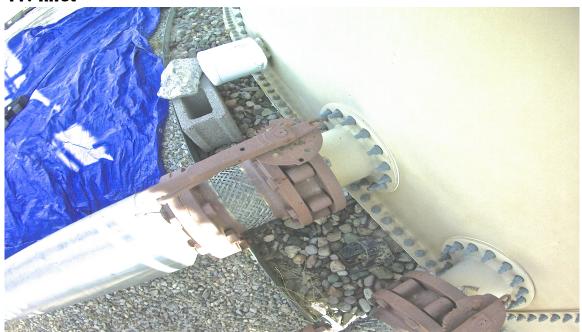
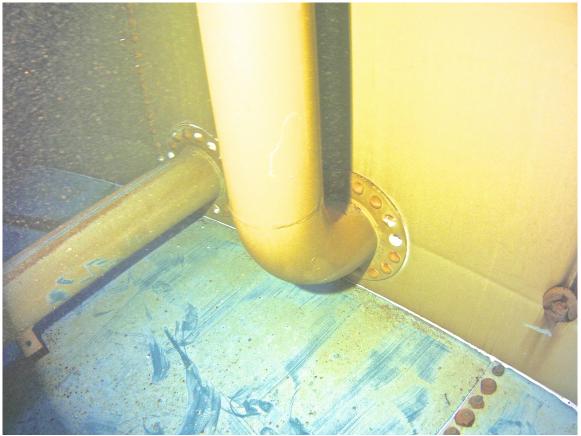
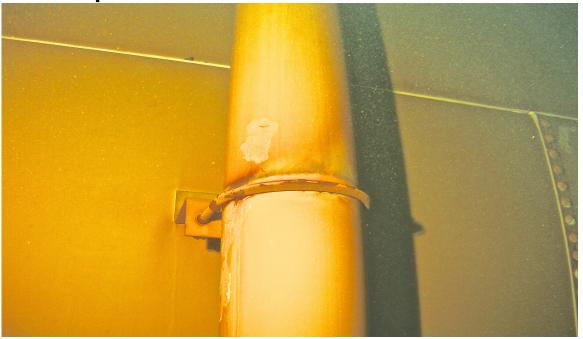
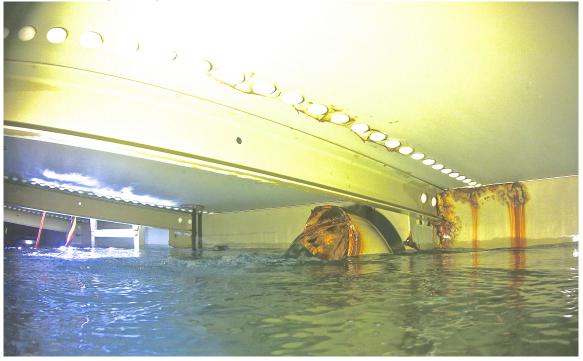
- 6" Diameter inlet good condition.
- Pipe has a 90-degree upturn near bottom and another 90-degree upturn at top.
- Pipe is structurally sound and secure to shell. (Unobstructed).
- No flaws observed.
- Recommendations:
  - o NA.

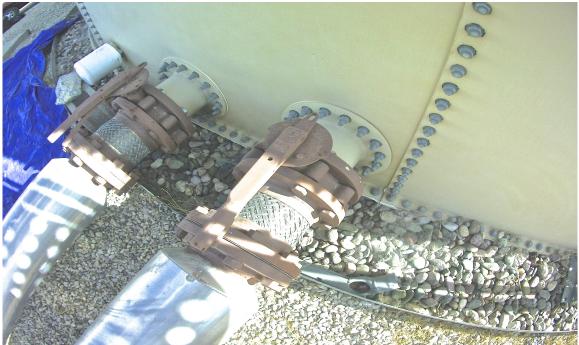
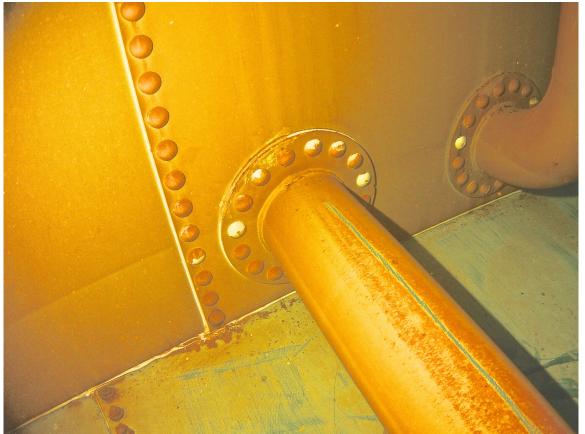
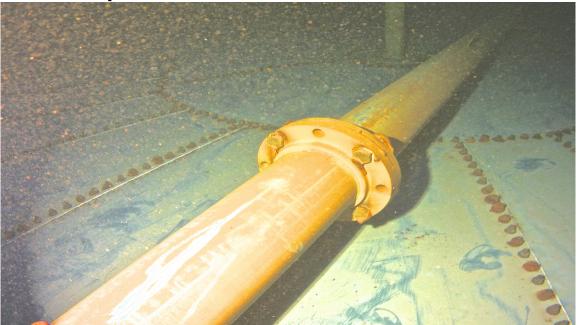
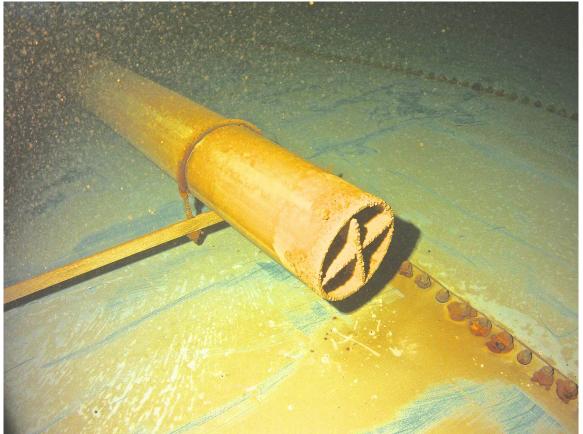
- 6" Diameter outlet good condition.
- Pipe is unobstructed, secure to shell and in good condition.
- Rust observed around penetration opening edge and on baffle.
- No other flaws observed.
- Recommendations:
  - Have divers touch up rust with an NSF approved epoxy at next inspection.

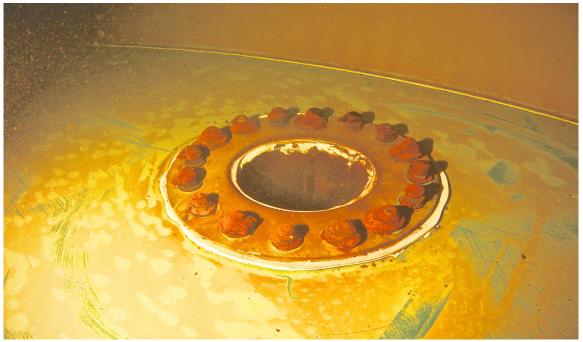
#### 49. Drain

- 6" Diameter drain (no mudguard) good condition.
- Structurally sound and unobstructed.
- Nuts and bolts around opening are covered with rust.
- No other flaws observed.
- Recommendations:
  - o NA.

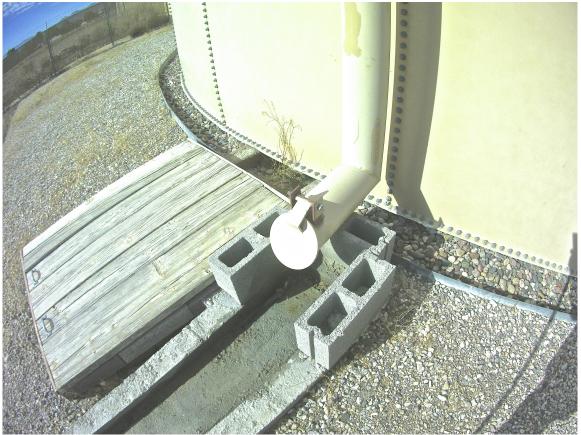
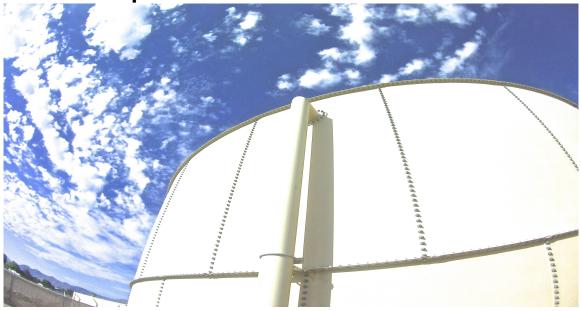
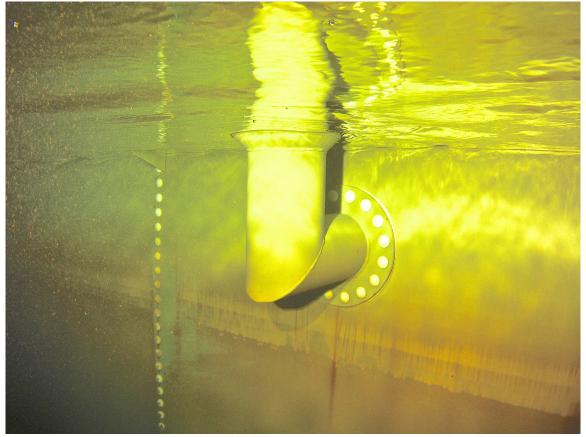
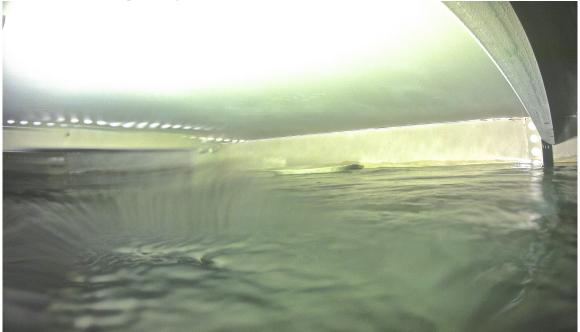
- 6" Diameter exterior & Interior overflow pipe good condition.
- Overflow pipe is unobstructed with no flaws observed on interior or exterior.
- Recommendations:
  - NA.

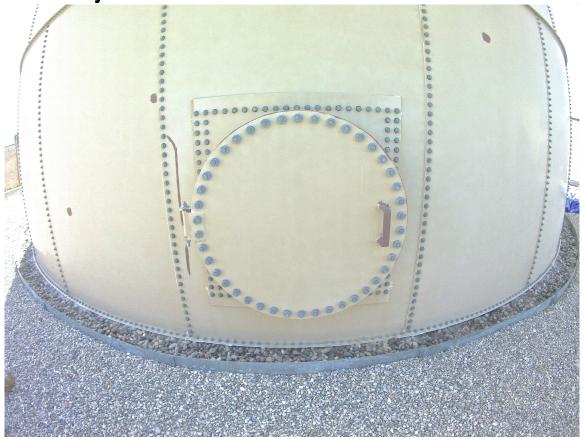
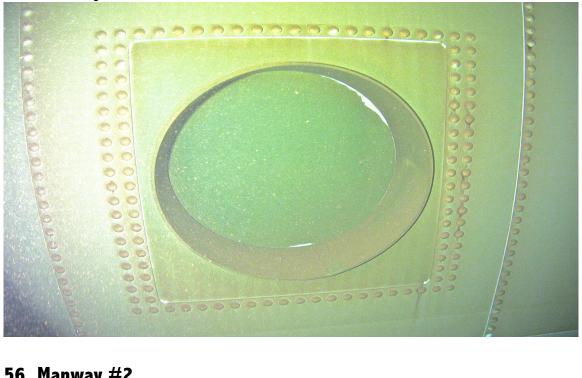
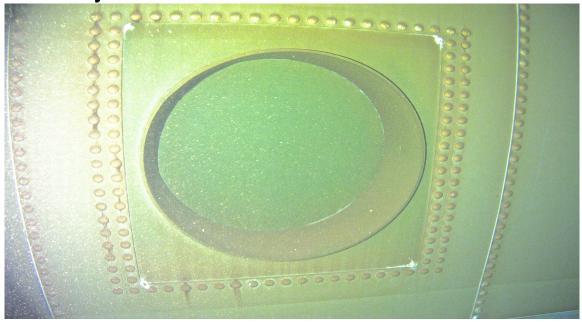
- 2 @ 30" diameter manways good condition.
- Seals are intact.
- No flaws observed around edges or on either manway face.
- Coating is similar to surrounding shell on both manways. (Chalky).
- Recommendations:
  - o NA.

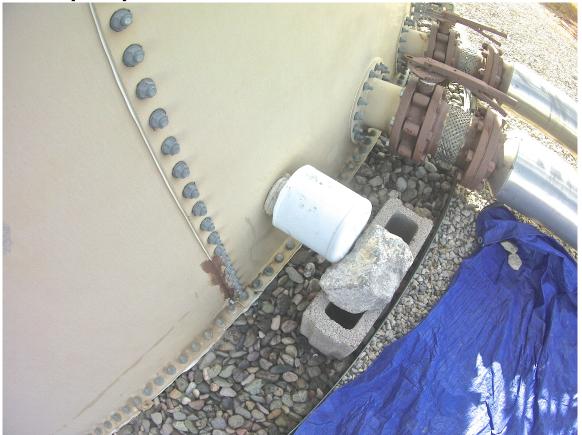
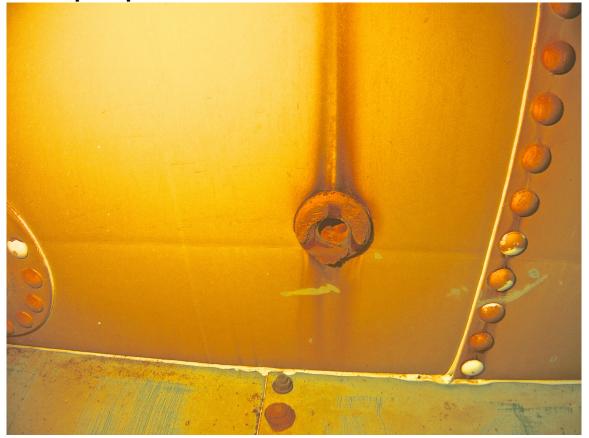
• Sample tap - good condition with rust forming around opening.
