#### Sky Ranch Estates - Owners Association

Sky Ranch Estate Reservoir

09/03/2019

On September 3<sup>rd</sup>, 2019 Blue Locker Commercial Diving Services, L.L.C. performed a cleaning and inspection of the Sky Ranch Estates Reservoir for the Sky Ranch Owners Association. This report, along with the provided video, documents the findings of the inspection.

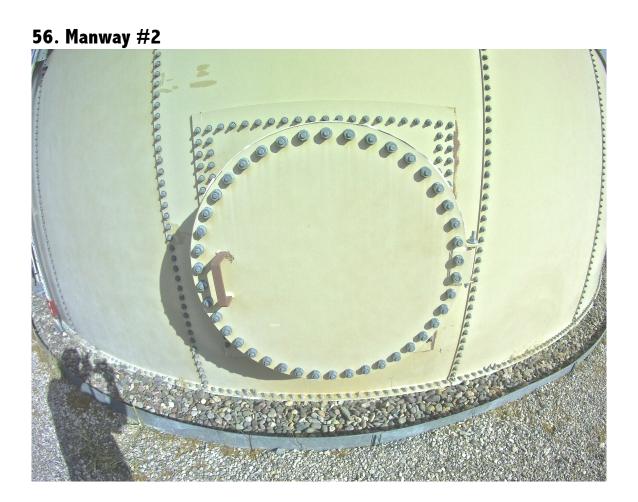
- 2 @ 30" diameter manways good condition.
- Seals are intact.
- No flaws observed around edges or on either manway face.
- Coating is similar to surrounding shell on both manways. (Chalky).
- Recommendations:
  - o NA.
